Manhole Inspection Summary

Manhole # S13C1_003MH

Location Address: **3107 Georgetown rd (alley behind address)**

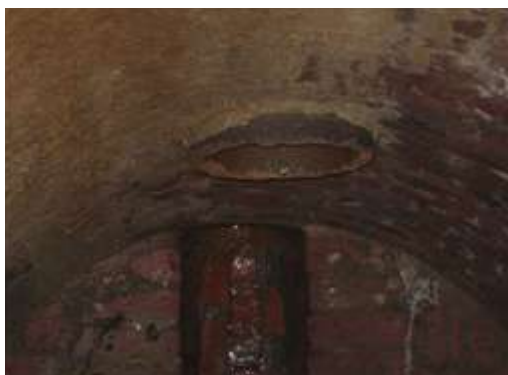
evidence of corbel infiltration

60cl pipe and drop// parged corbel

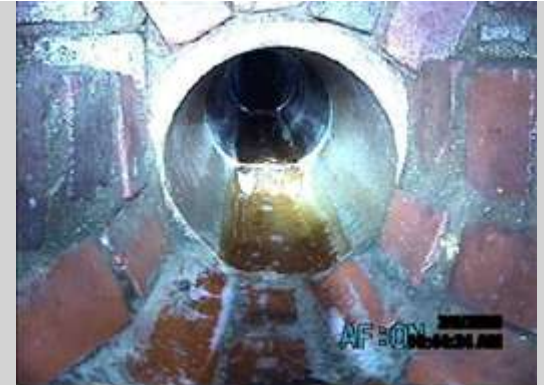
12 O'Clock Outflow

Pipe Height: **8.4** (in.) Rod and Bar (Angled)
Pipe Material: **Clay** ☐ Pipe Lined
Invert Depth: **11.58** (ft.) Flow Characteristics: **Slow**
Deposits: ☒ None ☐ Mud ☐ Sludge ☐ Debris ☐ Grease
Silt Depth: **0** (in.) Deposits Extent:
Infiltration: **None** Pipe Seal Cond: **Sound**

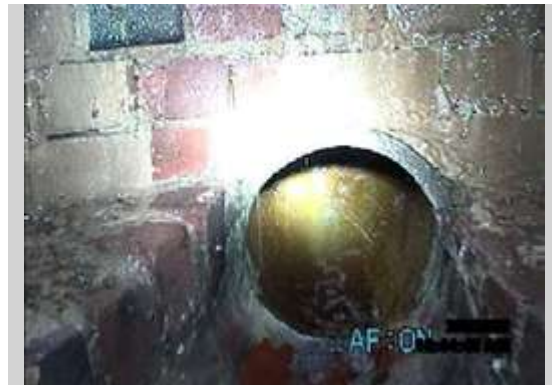
Drop In @ 3 O'Clock

Drop: **Outside** Rod and Bar
Angled: **Yes** Reading: **9.88** (ft.)
Inv Depth: **10.88** (ft.)
Drop Condition: **Open**

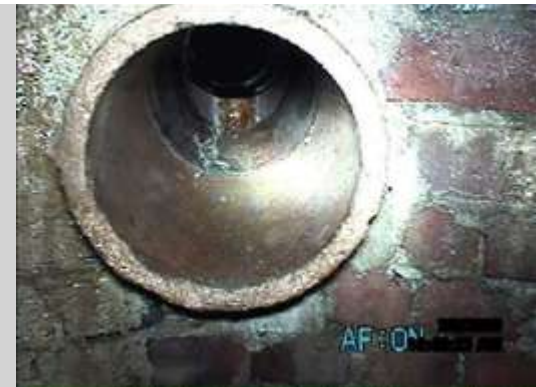
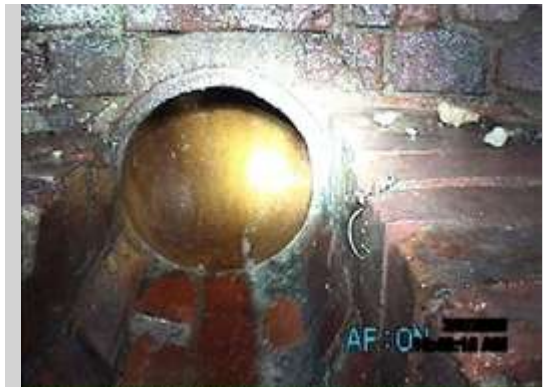
6 O'Clock Inflow

Drop: **Outside** Rod and Bar
Angled: **Yes** Reading: **10.08** (ft.)
Inv Depth: **11.08** (ft.)
Drop Condition: **Open**

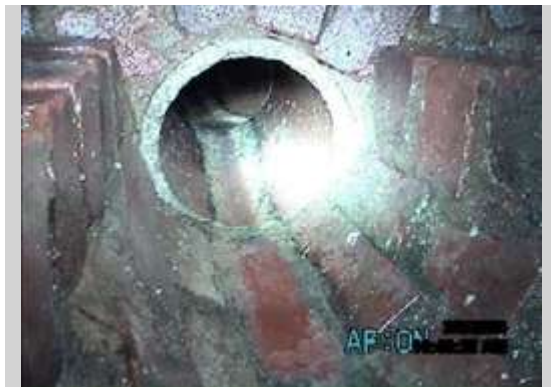
9 O'Clock Inflow

Pipe Height: **6** (in.) Rod and Bar (Angled)

Infiltration: **None** Pipe Seal Cond: **Sound**
